**The Prime Minister's Office**

**REPORT OF THE COMMISSION OF ENQUIRY TO  
INVESTIGATE THE ROAD ACCIDENT OF THE 29<sup>TH</sup> APRIL  
2014 ALONG THE MR3 FREEWAY AT MALAGWANE HILL  
PURSUANT TO LEGAL NOTICE NO. 66 OF 2014**

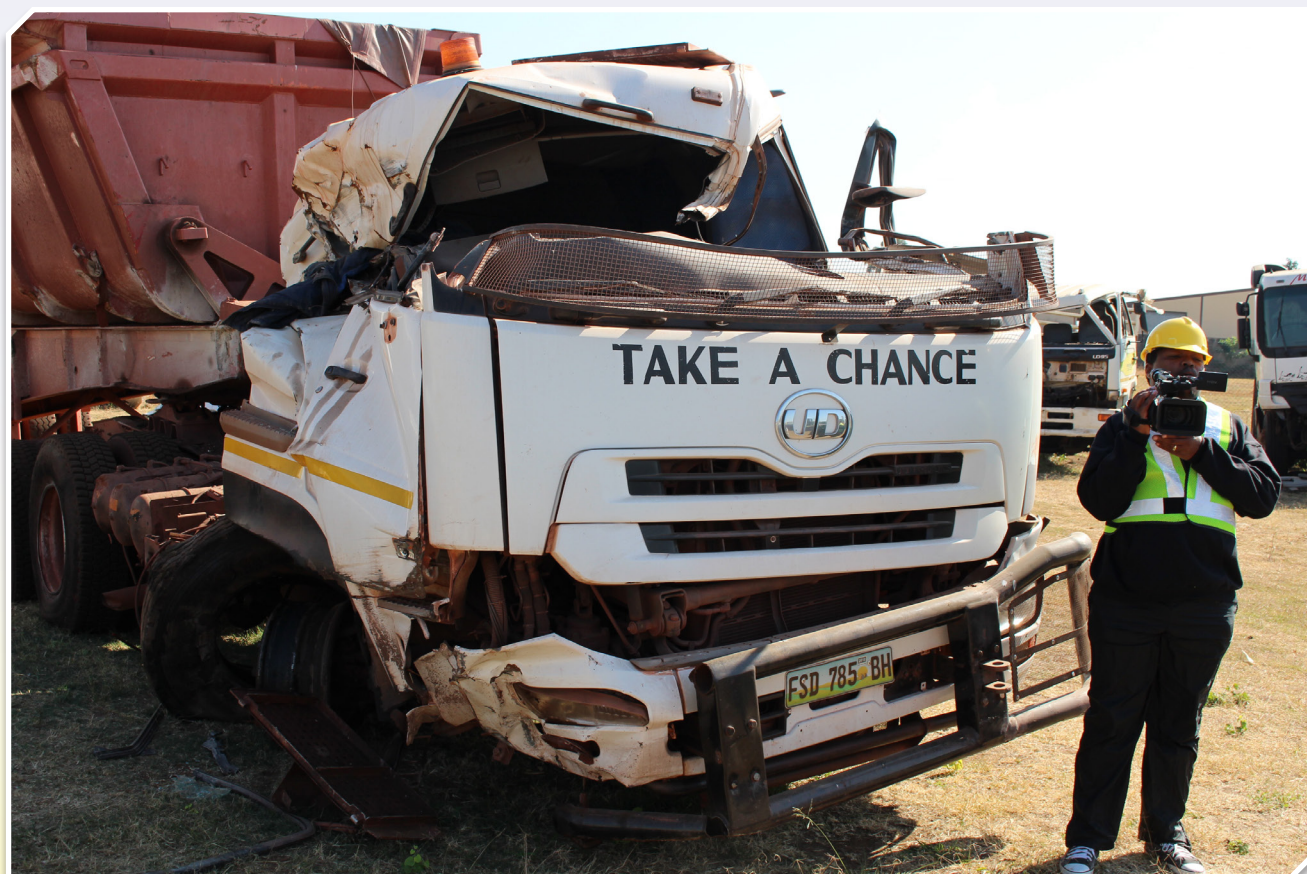
Figure 2.1: Phinduvuke “Take A Chance” Truck involved in the first accident

This truck was found to be road unworthy by the Government Motor Vehicle Examiner<sup>2</sup> because of the under listed reasons.

- (a) **Faulty Gear Box:** The accident was partly caused by a faulty gearbox. The driver of this truck, Mr. Sikhumbuzo Ceda Mkhonta alleges that the truck automatically disengaged the fourth gear and went into neutral; as a result of which he could not engage the forth gear as he was trying to navigate the truck when going down Malagwane hill.

- (b) **Braking System Failure:** The Senior Government Motor Vehicle Examiner inspected the truck after the accident and according to his findings; the braking system of the truck was malfunctioning and a Road Unworthiness Certificate was subsequently issued to “Take A Chance Transport” in respect of the vehicle in question.

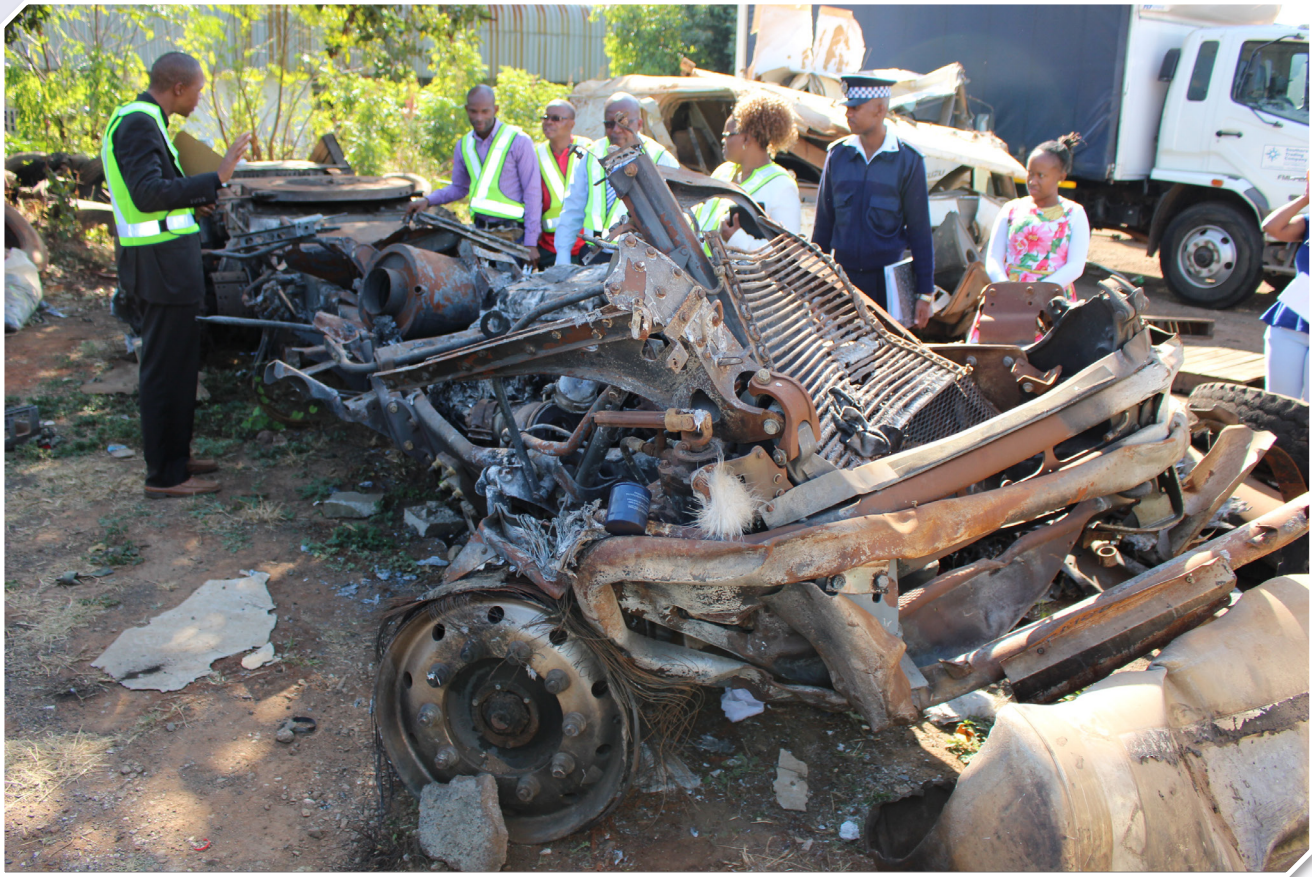
**Figure 2.2 Wreckage of Chrisilda Truck that was driven by Wilson Magagula.**

As a result of the fire that ensued after the crash, there was extensive damage to property, particularly motor vehicles. This was a particularly traumatic experience to motorists whose vehicles were not insured. The Commission is of the view that the accident was exacerbated by the fire because even vehicles that were not involved in the collision ended up catching fire.

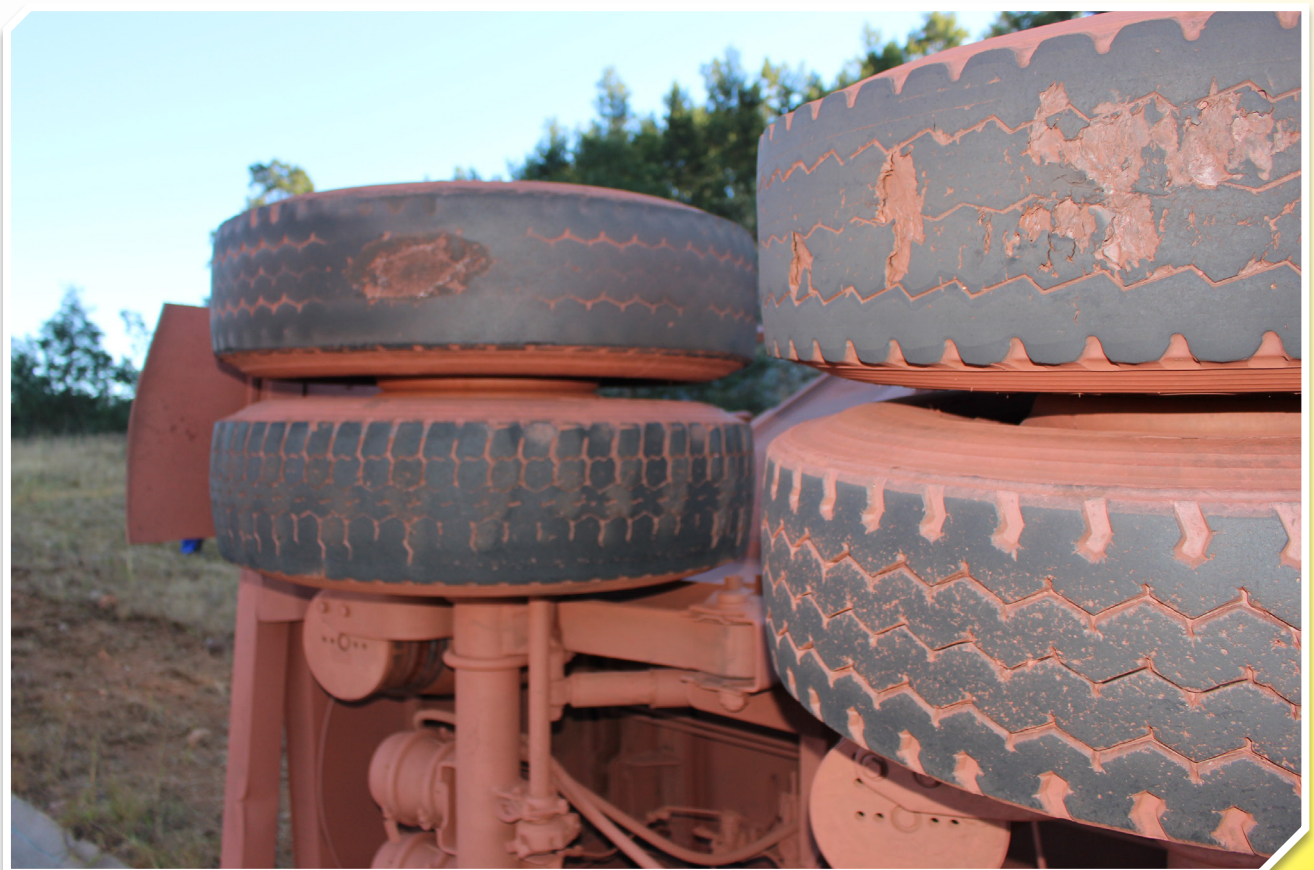
**Figure 2.4 Phinduvuke Truck that overturned at Nkoyoyo in Mbabane on the 2<sup>nd</sup> July 2014**

- (h) Phinduvuke Transport is further blameworthy in that their truck had a poor service record and the truck was road unworthy. The company's culpability for poor service is further validated by the accident that occurred on the 2<sup>nd</sup> of July 2014 at Nkoyoyo. The truck in question had worn out tyres and faulty brakes (see Figures 2.5 and 2.5 below).
